Coating Repair Products - Polypropylene

CRP-PP Repair Patch, PP Melt Stick and PP Adhesive Filler for Polypropylene coated pipelines.

PP Pipeline Repair Products

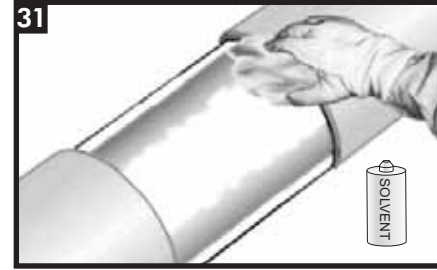
GTS-PP - Surface preparation

Once the coating is removed, then the sleeve shall be installed as per the detailed installation guide for GTS-PP. This includes full surface preparation as required in that install guide, and the application of the P-Primer Epoxy.
